Load Test Report

Report Number: 72095 February 13, 2019
Client: KLEVAKLIP SYSTEMS PTY LTD Page 1 of 4
Unit 63/176 South Creek Rd Cromer NSW 2099
Client Contact: Greg Doupe
Order Number: Refer Greg Doupe
Test Requirements: Load test of clip deck system as per the client's instructions.
Sample: 15 x Clipping deck systems and associated hardware.
Sample Identification: Klevaklip Snap-loc clip system for TREX decking
Test Date: 16/10/18, 13/02/19
Test Conditions: Ambient Temperature 20°C

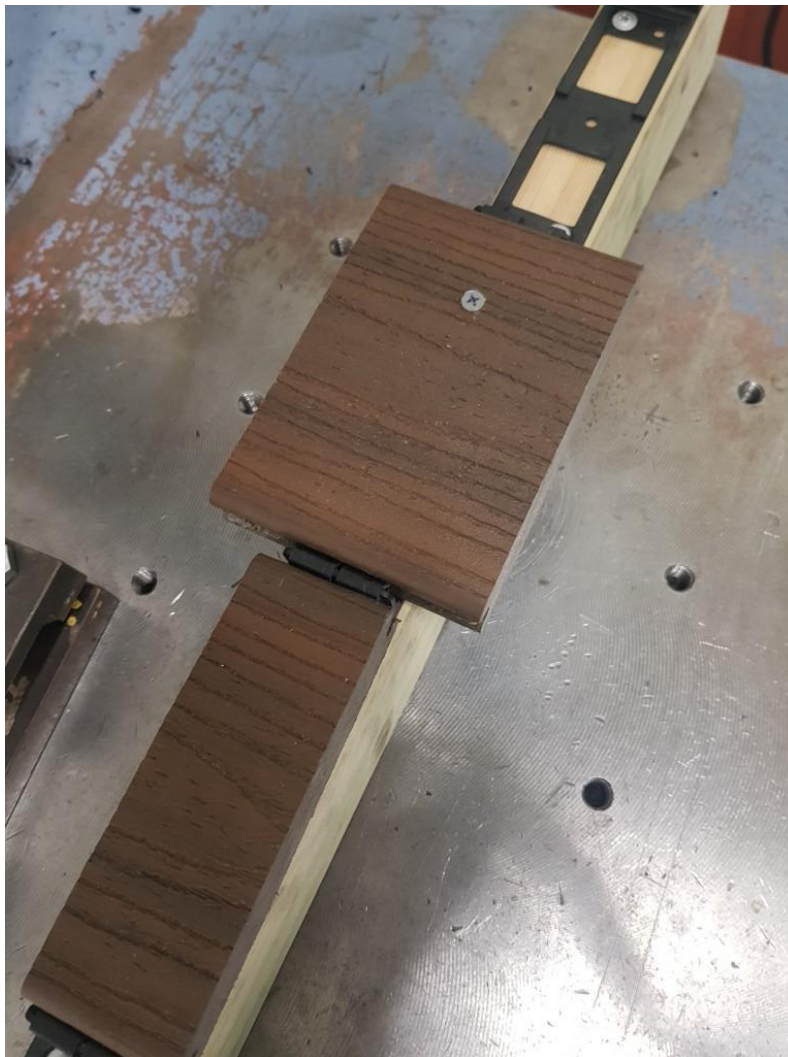
Figure 1: Installation method used for cyclone edge configuration.

Test Setup: Samples were tested in three different configurations. Six samples were tested with decking planks in both adjacent to simulate a middle plank. Three samples were tested with decking planks only on one side to simulate an edge plank. Six samples were tested with decking planks only on one side in addition a 65mm deck screw was installed to fix the plank to the joist to simulate an edge plank installation in cyclone regions (refer to figure 1).

Sample	Configuration	Maximum load (N)	Maximum load (kg)	Observations
1	One adjacent plank present and 65mm screw fixing (cyclone installation)	4290	437.3	Pop out/screw pulled out
2		4939	503.5	Pop out/screw pulled out
3		4828	492.1	Pop out/screw pulled out
4		4332	441.6	Pop out/screw pulled out
5		4800	489.3	Pop out/screw pulled out
6		4646	473.6	Pop out/screw pulled out
Average		4639	472.9	-

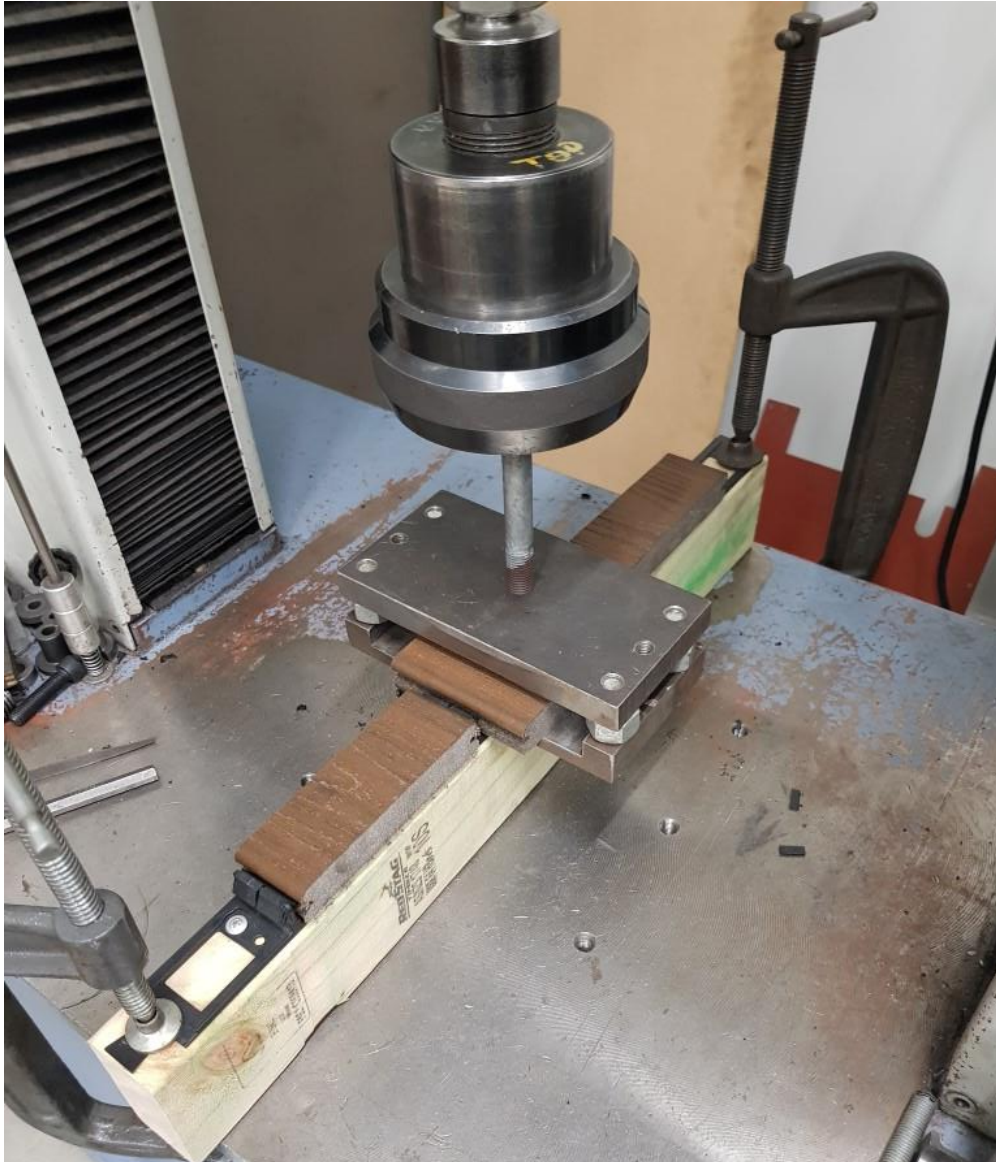
Figure 2: Test setup used to test middle plank configuration.

Sample	Configuration	Maximum load (N)	Maximum load (kg)	Observations
1	Two adjacent planks present	1632	166.4	Clip failed
2		1612	164.3	Clip failed
3		1730	176.4	Clip failed
4		1591	162.2	Clip failed
5		1646	167.8	Clip failed
6		1549	157.9	Clip failed
Average		1623	165.8	-
1	One adjacent plank present	865	88.2	Clip bent until pop out
2		991	101.0	Clip bent until pop out
3		928	94.6	Clip bent until pop out
Average		928	94.6	-

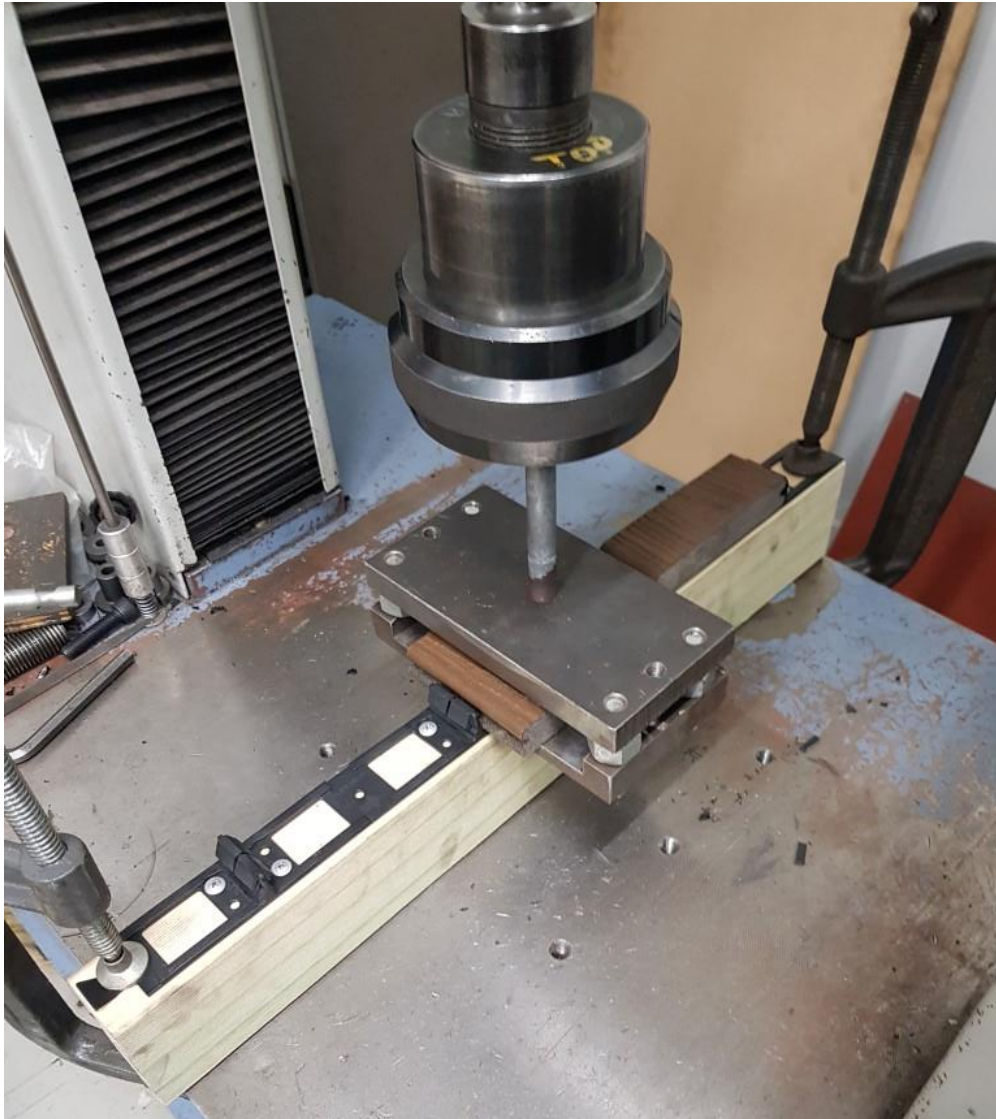
Figure 3: Test setup used to test edge plank configuration.
