Load Test Report

Report Number: 29765 Reissue A March 30, 2016
Client: KLEVAKLIP SYSTEMS PTY LTD Page 1 of 3
Address: Unit 3 / 176 South Creek Rd, Cromer NSW 2099
Client Contact: Greg Doupe
Order Number: Refer Greg Doupe
Test Requirements: Load test of floor joist as per client's instructions.
Site Address: Unit 3 / 176 South Creek Rd, Cromer NSW 2099
Sample Identification: Nylon joist hangers
Test Dates: 12/2/16

Test: AS 1170.1-2002 Part 3.4

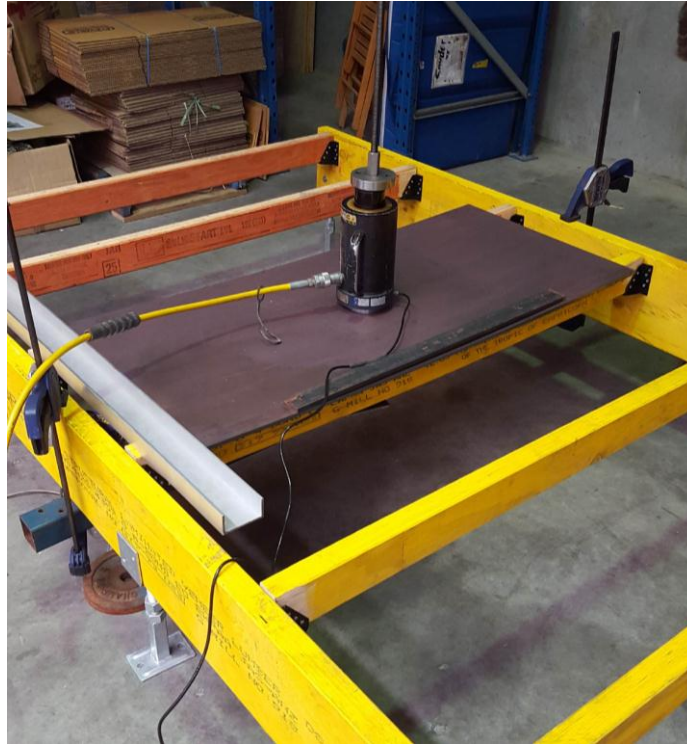
Figure 1: Joist hangers test setup

Test Setup: Joist hangers were installed by client with joist span on 1.5m and 0.45m centres. Loads were distributed over the majority of the span via a steel plate testing four joist hangers simultaneously.

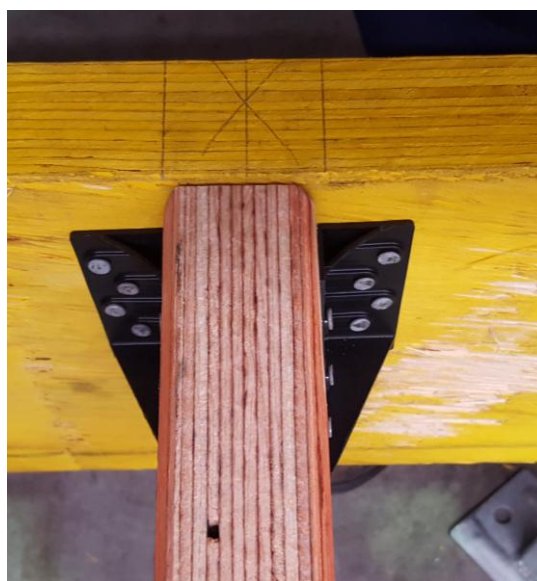
Figure 2: Example of joist hanger tested

Sample	Load (kN)	Pressure over area (kPa)	Observations	Deflection under load (mm)	Permanent set (mm)	Compliance
1	12	17.8	No damage or loosening	4.0	0.5	Complies
	20	29.6	No damage or loosening	6.5	0.5	Complies
2	12	17.8	No damage or loosening	3.5	1.0	Complies
	20	29.6	No damage or loosening	5.0	1.0	Complies
3	12	17.8	No damage or loosening	3.0	0.5	Complies
	20	29.6	No damage or loosening	5.0	1.0	Complies

Compliance: The joist hangers tested comply with AS1170 for serviceability loading (permanent set < 30% of deflection) and ultimate loading (no collapse under load) when loaded to the loads outlined in AS1170.1 part 3.4.
